**Finite Element-based Parametric and Probabilistic Analysis of Structural
Deterioration in Corroded Pre-stressed Concrete Girders**

A thesis submitted in partial fulfillment of the requirements for the degree of

STRUCTURAL ENGINEERING

University of Alberta

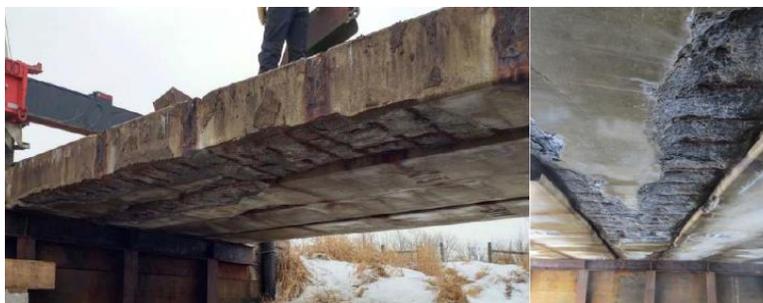
Nine girders were salvaged from an abandoned bridge (1990 - 2017) near Barrhead in central Alberta (see Figure 4-1 a). Four out of seven interior girders have been tested to failure in the I. F. Morrison Structures Laboratory at University of Alberta to study their residual performance. The interior bridge girders are of type SM-510, 11 m long with a solid cross-section at both ends as the rigid-end diagrams and a three-cell hollow cross-section in the middle as shown in Figure 4-1 (b). The three-cell hollow cross-section is 1206 mm in width and 510 mm in depth, and each of the three voids is circular with a diameter of 300 mm as provided in blueprint. The concrete, made of lightweight coarse aggregate and sand fines, is semi-light weight with a mass density of 1920 kg/m^3 , and the specified (nominal) concrete compressive strength is 35 MPa according to the blueprints. There are 20 pre-stressed seven-wire low-relaxation strands and 7 M10 steel re-bars (i.e., 5 G1012 and 2 G1013) of Grade 400 as shown in the cross-section in Figure 4-1 (b). The

Figure 4-1: (a) The abandoned bridge near Barrhead, and (b) a representative cross-section of a interior bridge girder (courtesy of Alberta Transportation)

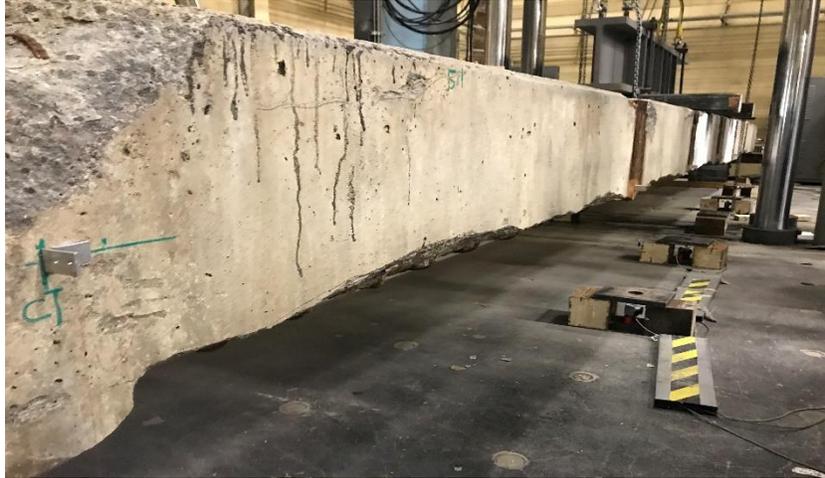
(a)

All girders removed from the bridge were visually inspected before the tests and girder #1 was considered as the one in the best condition. Additionally, an interior PC girder with the most severe deterioration (denoted as girder #2) was tested to determine the structural behaviour and further study the effect of deteriorations. The tested data was used to infer the deterioration states in the PC girder according to the parametric study performed earlier. Salvaged from the same bridge, girder #2 has the same dimensions with girder #1 that has least deterioration based on visual inspection. Before the flexural test, concrete spalling was observed at both bottom and top of the girder as shown in Figure 4-32 (a). The dimensions of spalling areas were measured before the test and indicated by the blue zones sketched in Figure 4-32 (b). In most of spalled zones, the depth exceeded the concrete cover depth and the reinforcements are exposed with some cross-section area deduction due to corrosion. The flexural test followed the same setup as the test of girder #1; as a result, the FE modelling strategy for girder #2 is the same as that for girder #1, as shown in Figure 4-33. Similarly, material models and properties used in the FE model are the same as the ones used for girder #1 since they are from the same bridge. Nevertheless, the measured concrete spalling is incorporated into the FE model for girder #2.

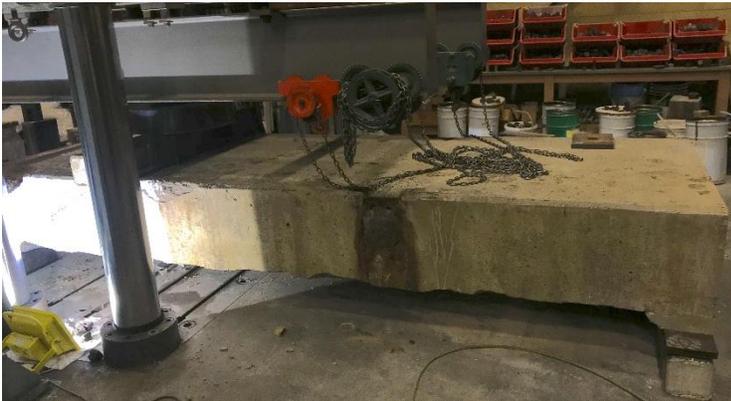
Figure 5-15: Picture of shear girder #2
